Home Inspection Report

Inspection #: 202508-61419

Inspection Address: 1448 Hidden Meadow Lane,
Salisbury MD 21801

Inspection Company: **Amerispec**

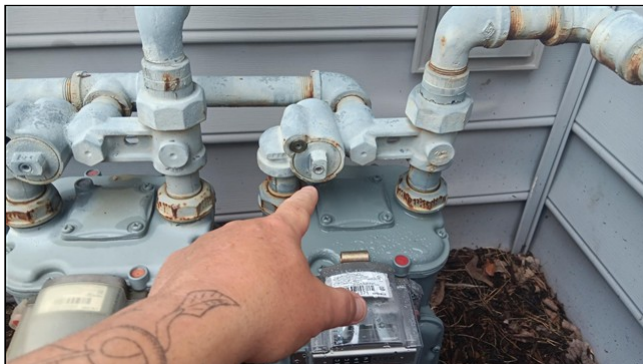
1.11 Item 1 (Picture)

Gas is off at meter, unable to operate gas appliances. All systems are supposed to be on for inspection, therefore this is listed as a major concern item. Recommend verifying safe and proper operation of all gas appliances prior to settlement.

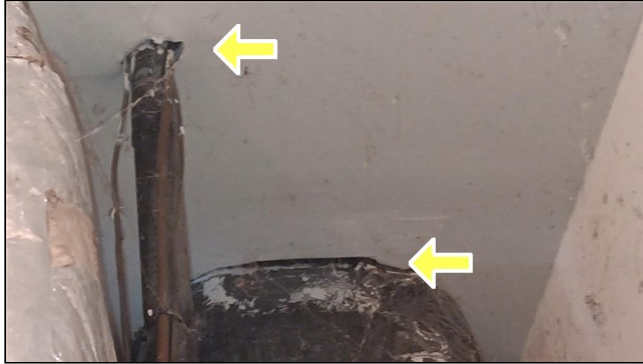
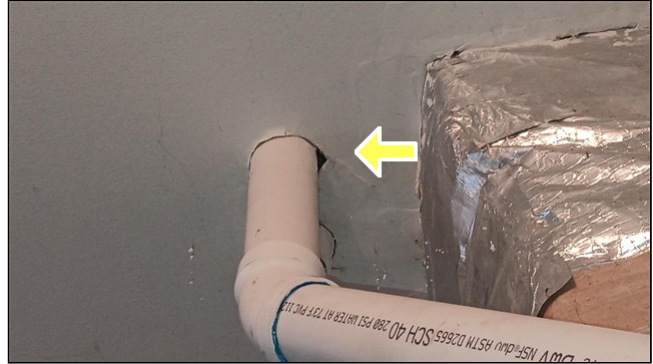
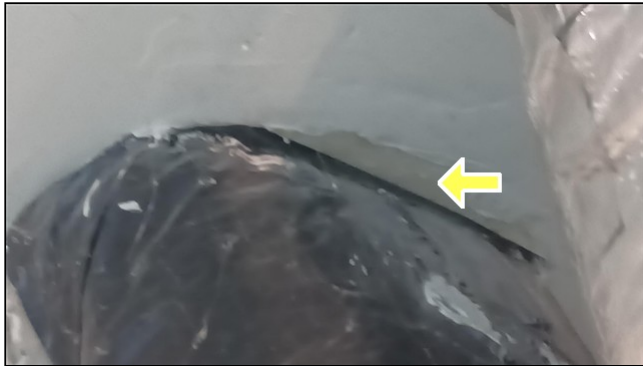
Fire rating of the garage wall is compromised as a result of holes, cracking, loose drywall tape or thru wall penetrations. This is a safety concern. Recommend repairs as necessary to correct.

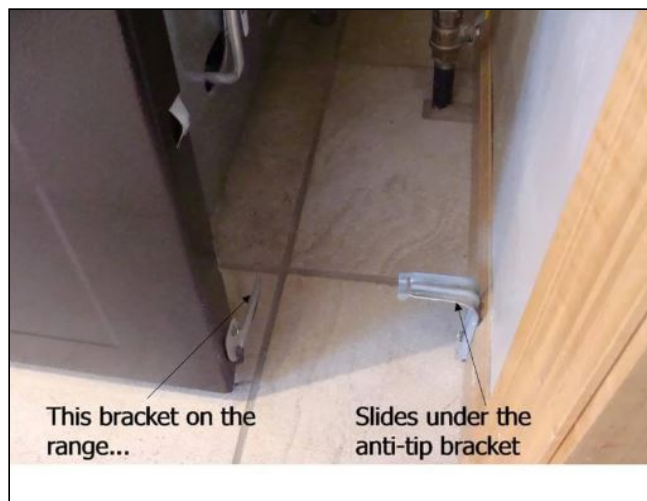
11.2 Item 3 (Picture) Anti Tilt Bracket Diagram Photo

A stove anti tip over device has not been installed on this unit. If a child steps on the open door or if a heavy pot is placed on the door, the door acts like a lever forcing the front of the stove down and then back up. Not only will the stove tip and possibly land on your feet, but anything on the range top, such as a pot of boiling water which could cause serious injury. An anti tip bracket can be attached to the bottom of the wall behind the stove by a licensed general contractor. The stove will still slide in and out but will not tip over. Recommend installing to ensure safety. (Attached photo is an example, not the actual unit).

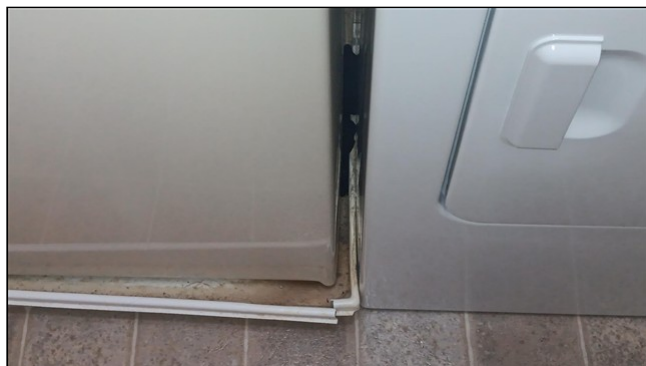
13.0 Item 1 (Picture)

The overflow pan is damaged, recommend repairing/replacing as the unit is located above or within living space.

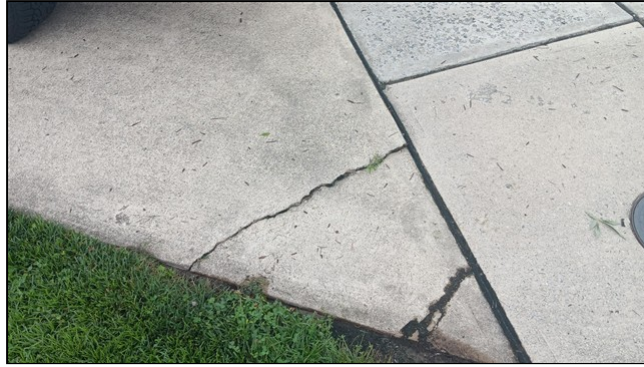
1.0 Item 1 (Picture)

Settlement observed. We suggest review by Licensed/Qualified professional for repair or replacement as necessary.

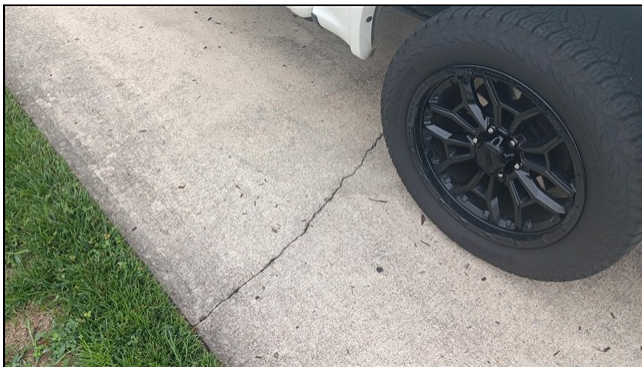
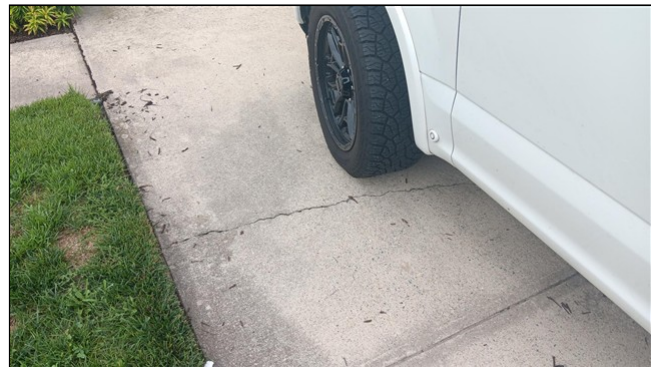
Common cracks observed, primarily a cosmetic concern. We suggest sealing all cracks in surfaces to prevent water penetration as a routine maintenance effort.

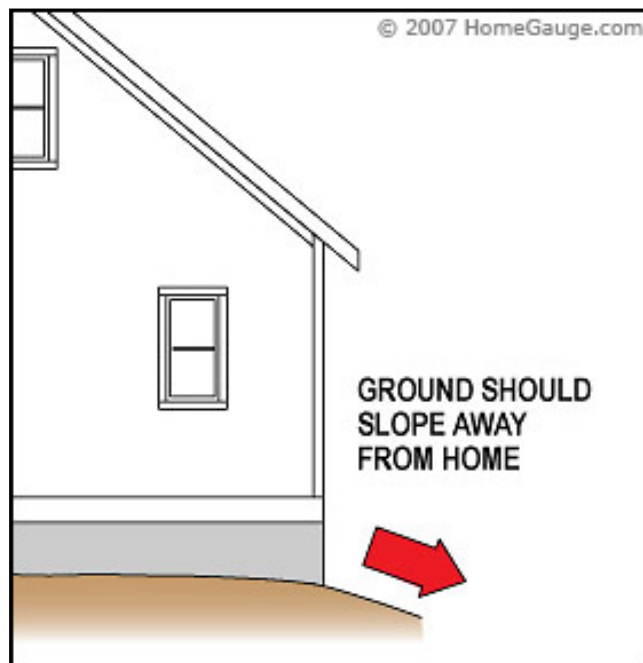
1.3 Item 1 (Picture) Lot Pitch

Recommend adding dirt back-fill to any low lying areas around the foundation to ensure proper drainage away from the foundation at all times. Slope should fall away from the foundation at a minimum of 1/2 inch per foot and extend at least 10 feet away from the foundation.

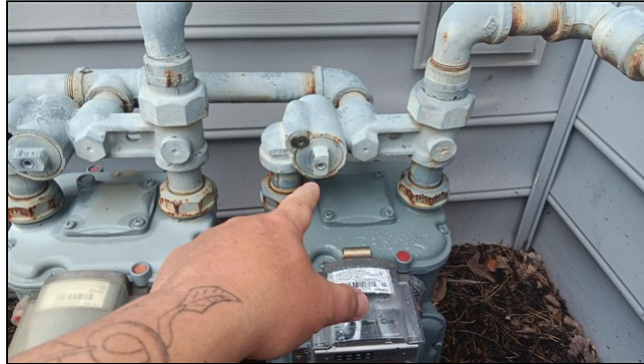
1.11 Item 1 (Picture)

Gas is off at meter, unable to operate gas appliances. All systems are supposed to be on for inspection, therefore this is listed as a major concern item. Recommend verifying safe and proper operation of all gas appliances prior to settlement.

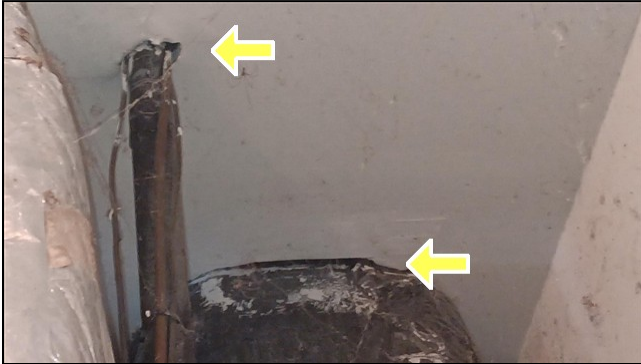
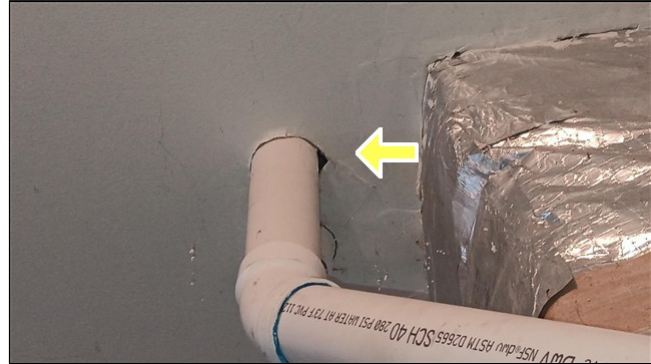
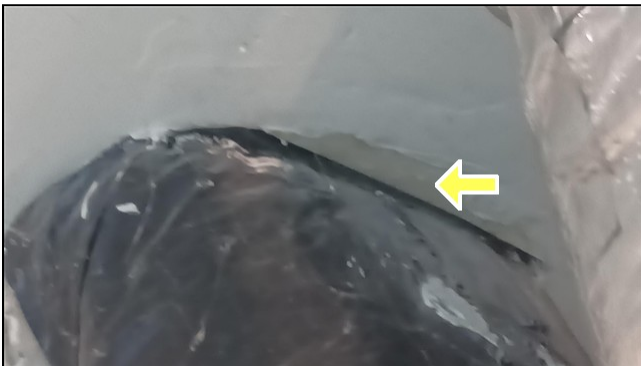
Fire rating of the garage wall is compromised as a result of holes, cracking, loose drywall tape or thru wall penetrations. This is a safety concern. Recommend repairs as necessary to correct.

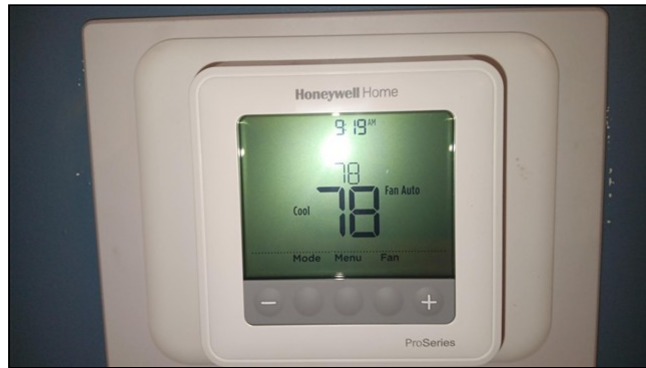
7.1 Item 1 (Picture)

Upon arrival thermostat was in cool mode and set at 78 degrees.

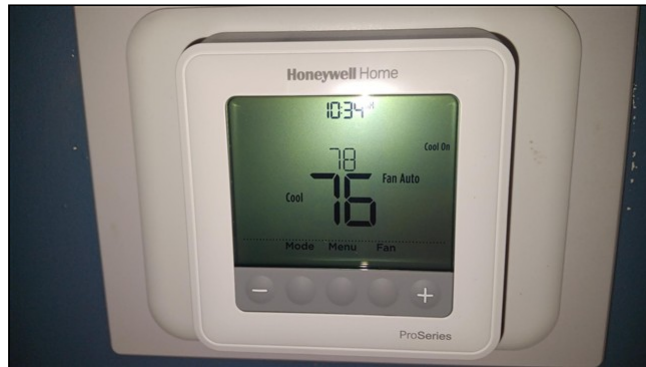
7.1 Item 2 (Picture)

Upon inspectors departure thermostat was set back to cool mode and set back to 78 degrees.

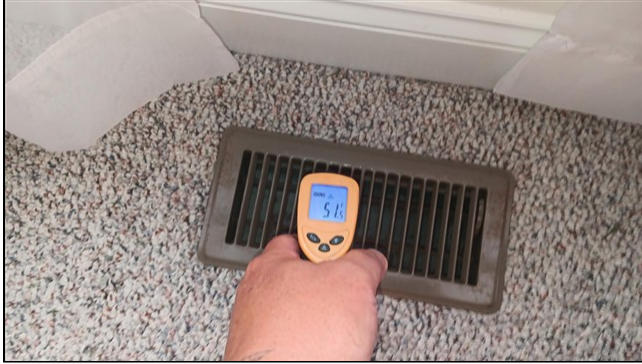
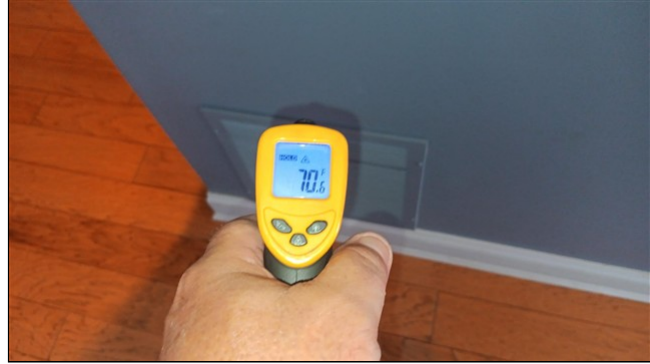
Unit was tested and was serviceable at time of inspection. A temperature drop was performed across the evaporator coil of this unit. When tested, temperature at supply register was 51 degrees, temperature at return was 70 degrees, which is a difference of 19 degrees which is within the 14 to 22 degree normal operating range.

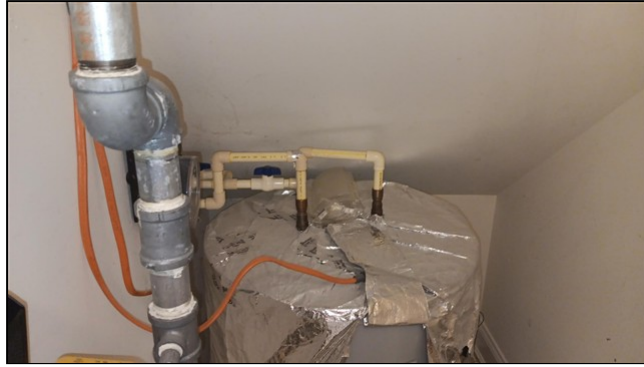
10.0 Item 1 (Picture)

The water heater does not have a "Thermal Expansion Tank" installed to prevent a possible leak at the TPR valve. Recent changes in standard building practice require one when a new water heater is installed. This change is not retroactive on older previously installed water heaters. There were no leaks or drips at the TPR valve during inspection. If the water heater does begin to drip or leak, then a thermal expansion tank may be needed.

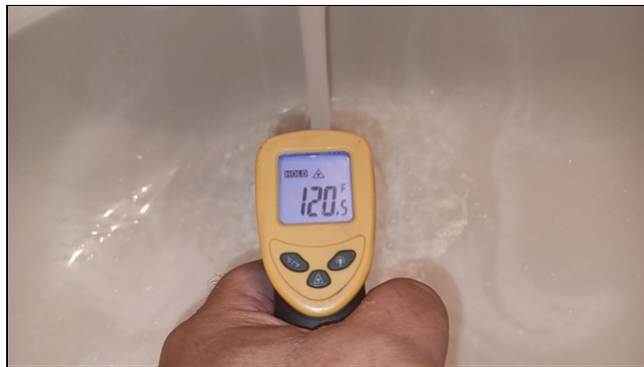
10.1 Item 1 (Picture)

The water temperature at time of inspection was 120 degrees.

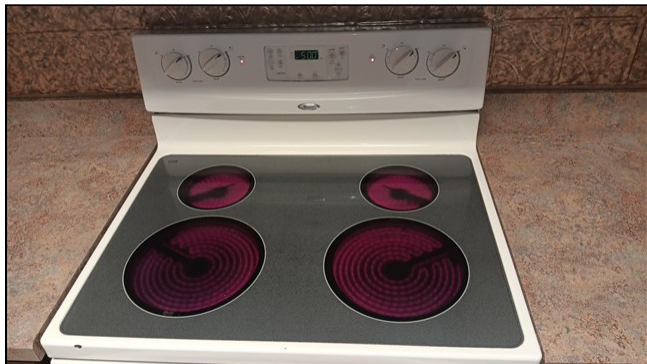
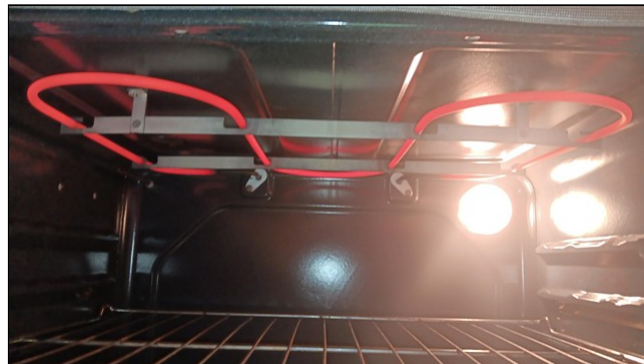
NOTE: The electrical stove/range elements were tested at the time of inspection and appeared to function properly. These can fail at anytime without warning. No warranty, guarantee, or certification is given as to future failure.

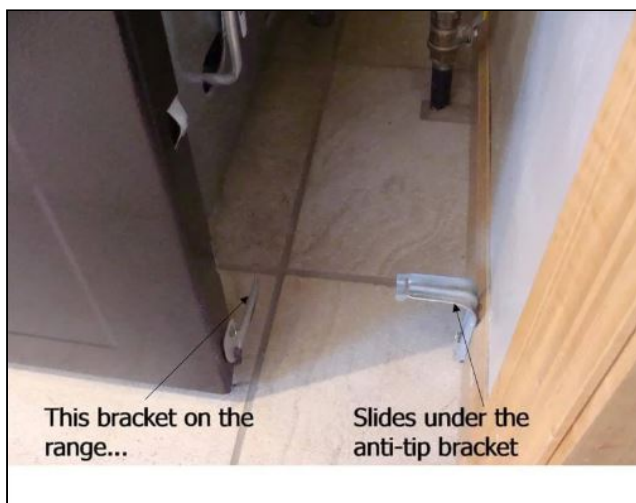
11.2 Item 3 (Picture) Anti Tilt Bracket Diagram Photo

A stove anti tip over device has not been installed on this unit. If a child steps on the open door or if a heavy pot is placed on the door, the door acts like a lever forcing the front of the stove down and then back up. Not only will the stove tip and possibly land on your feet, but anything on the range top, such as a pot of boiling water which could cause serious injury. An anti tip bracket can be attached to the bottom of the wall behind the stove by a licensed general contractor. The stove will still slide in and out but will not tip over. Recommend installing to ensure safety. (Attached photo is an example, not the actual unit).

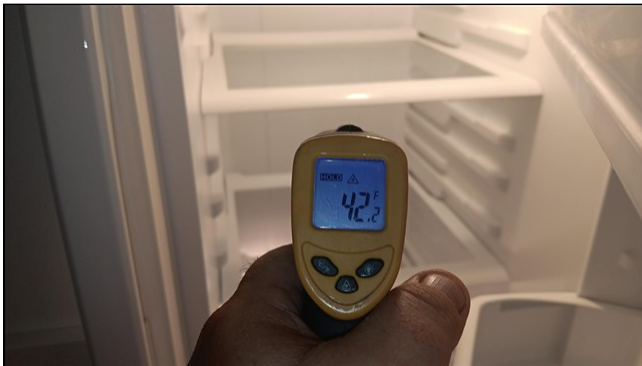
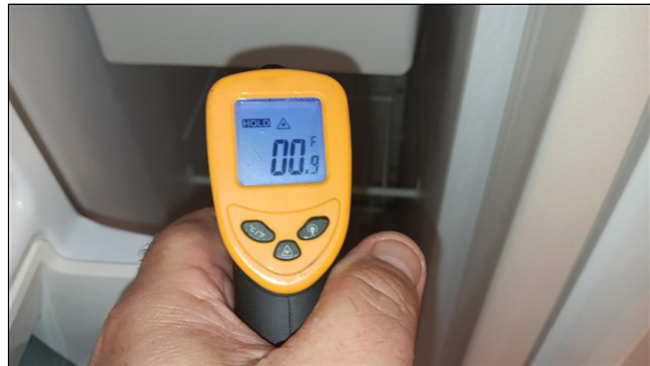
The refrigerator/freezer, freon levels, icemaker operation and other specialty items are beyond the scope of inspection. A temperature reading ONLY was taken for your information only. The refrigerator should be kept at or below 40 degrees fahrenheit and the freezer at or below 0 degrees. The refrigerator supplied temperature at 42 degrees and the freezer at 0 degrees.

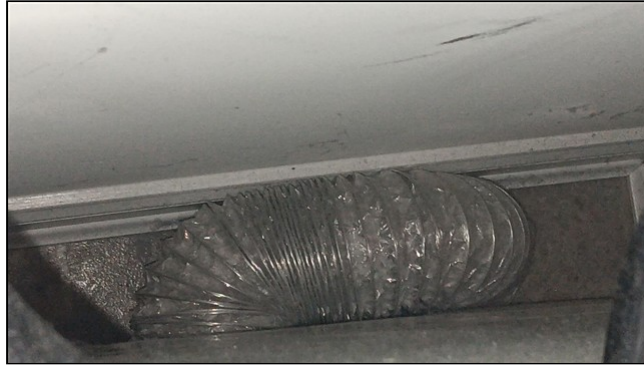
13.2 Item 1 (Picture)

Dryer vent material is foil type, recommend replacing with smooth metal vent pipe upon taking ownership as this is considered a potential fire hazard. As a safety measure, we recommend replacing this exhaust hose with an approved metallic dryer vent duct.

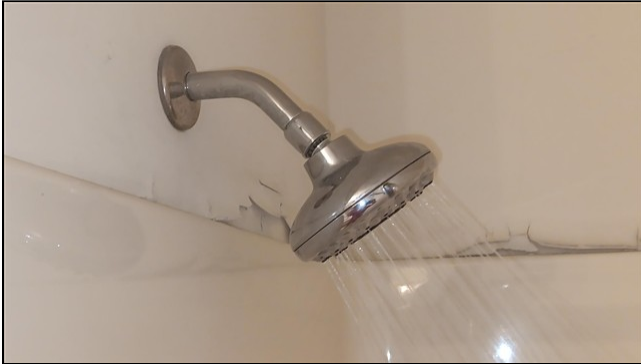
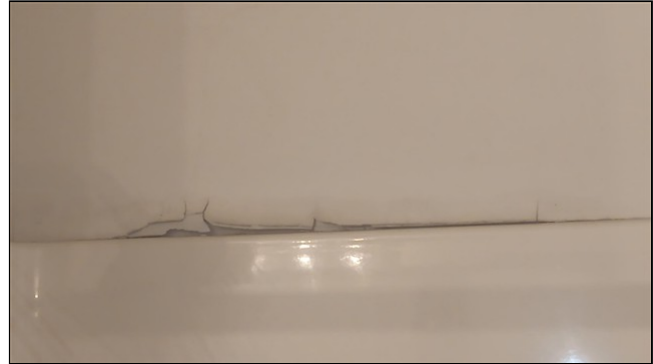
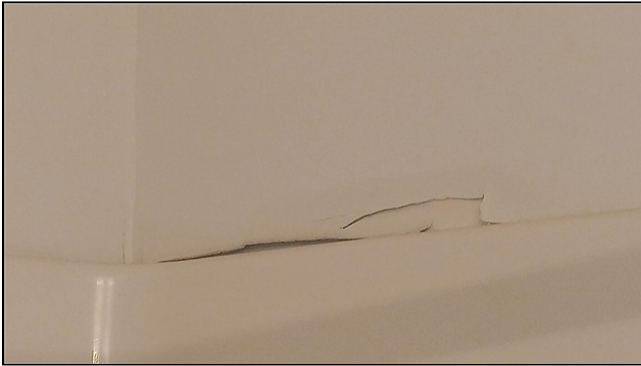
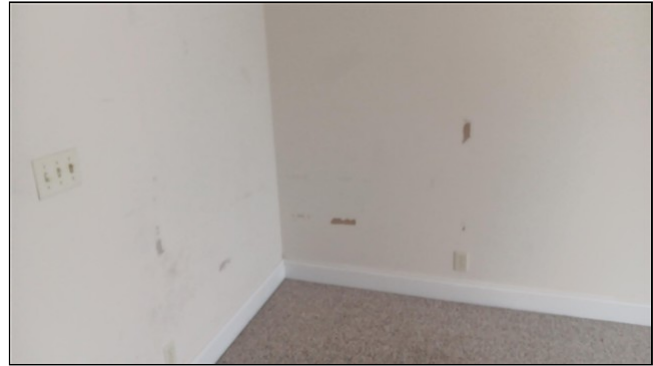
Minor drywall damage observed in the master bathroom shower and master bedroom. This is a cosmetic concern. Recommend patching.

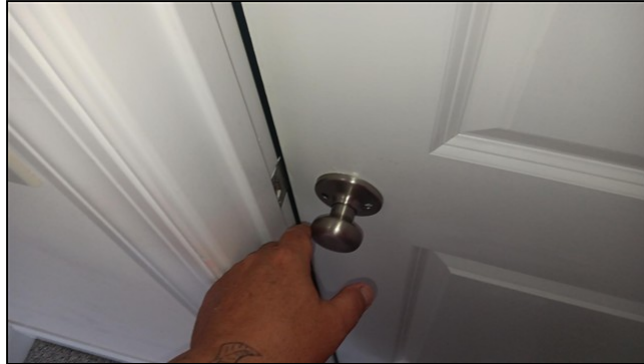
14.3 Item 1 (Picture)

The right rear bedroom closet door does not latch properly; suggest repairs / adjustments for proper operation and to ensure privacy / security.

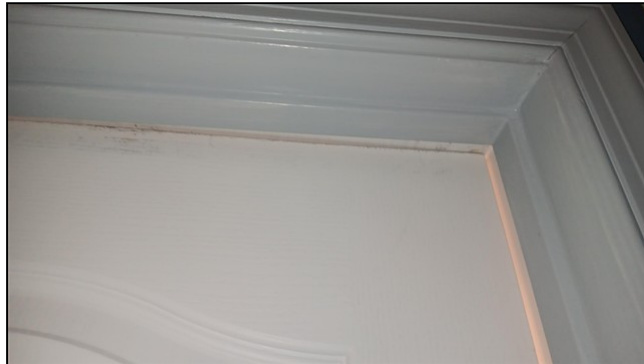
14.3 Item 2 (Picture)

The door in the hall bathroom rubs the jamb, recommend adjustments for smooth operation.
