## Home Inspection Report

Inspection #: 202604-63182

Inspection Address: 30034 Seashore Park Drive,  
Millville DE 19967

Inspection Company: **AmeriSpec**

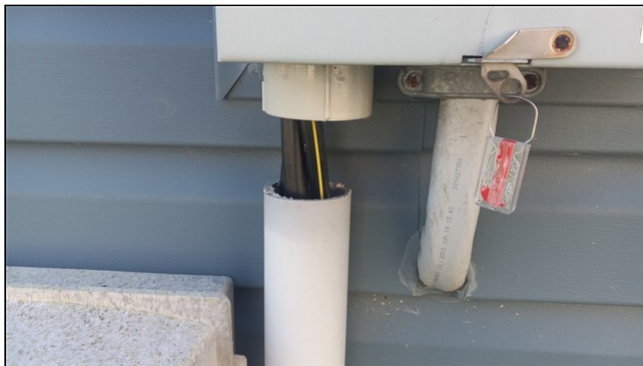
1.11 Item 1 (Picture)

Conduit is separated from the meter exposing service wires which is a possible shock hazard. Recommend contacting utility company for repair

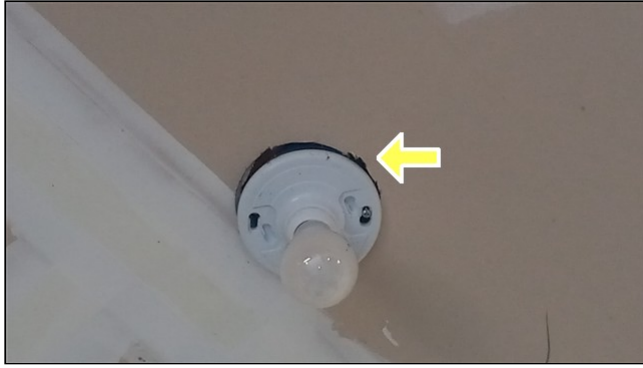
2.4 Item 1 (Picture)

Fire rating of the garage wall is compromised as a result of holes, cracking, loose drywall tape or thru wall penetrations. This is a safety concern. Recommend repairs as necessary to correct.

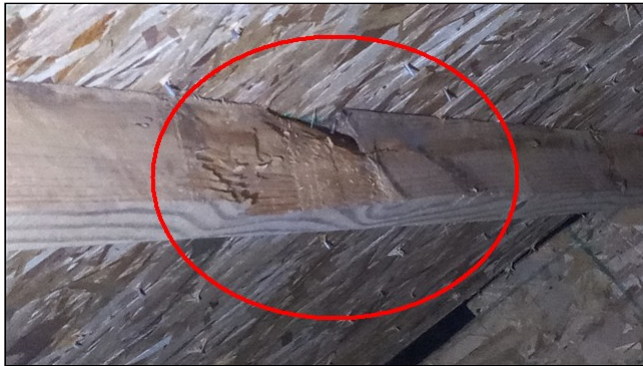
4.1 Item 1 (Picture)

Broken/damaged truss(es) observed in the main attic accessed from the 2nd floor. Trusses are engineered systems requiring each component to be intact to distribute loads as the design engineer intended. Recommend further review by manufacturers engineer and obtaining engineers written repair instructions, having a qualified contractor repair the truss according to the instructions to ensure proper structural support. Attach paperwork to repaired truss per engineers seal to have for future inspections / reference.

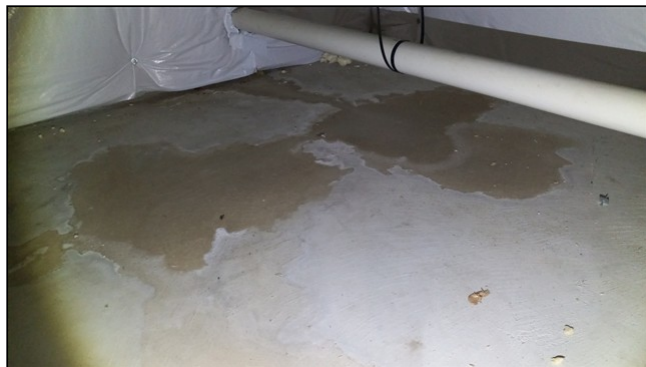
5.0 Item 1 (Picture)

Staining is present at various locations in the crawlspace which is an indication of prior moisture. Recommend further review and repair as necessary

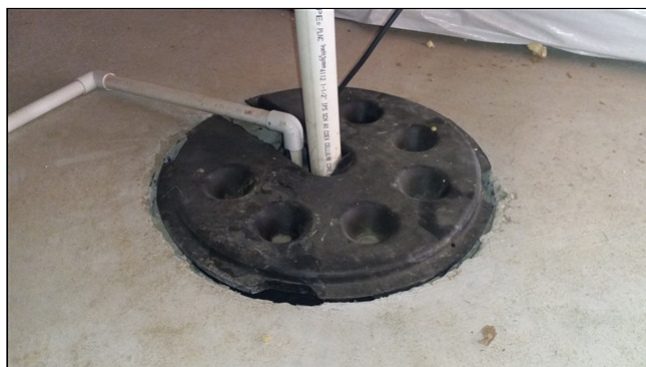
5.4 Item 1 (Picture)

Inoperable at the time of inspection. Recommend repair / replacement as necessary.

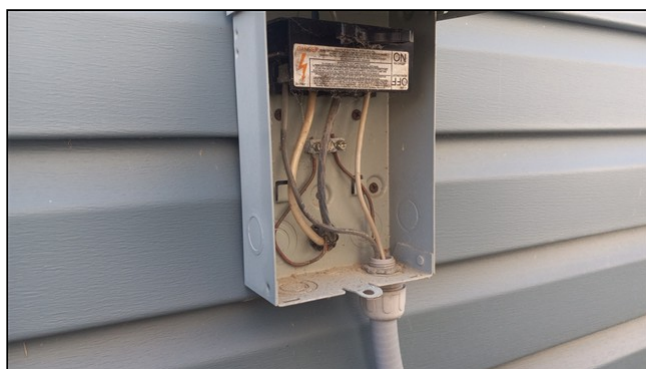
8.3 Item 1 (Picture)

The wiring is exposed. Recommend repair as necessary.

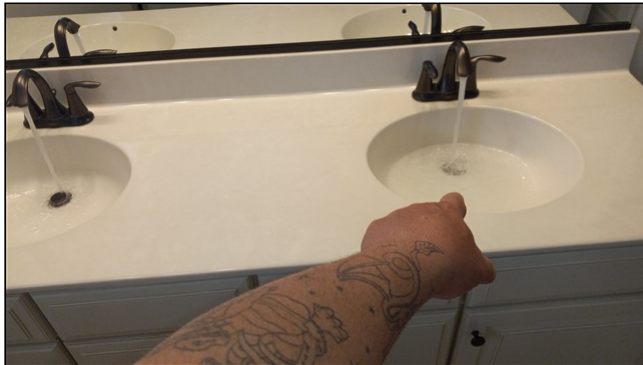
12.1 Item 1 (Picture)

The sink does not drain properly (clogged / slow draining) at the master bathroom. Recommend repairs as needed.

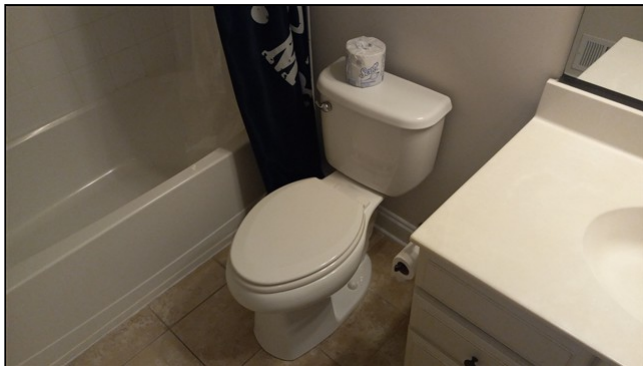
12.2 Item 1 (Picture)

The toilet bowl is moderately to significantly loose at floor anchor bolts in the hall bathroom. The inspector is unable to determine if this is the result of a broken flange or if simply tightening will resolve. The wax ring inside the unit must have a snug, secure fit in order to keep from leaking. Properly re-sealing and re-securing this unit is suggested to prevent water leakage and damage to the sub-floor area. This type of damage is not always visible or accessible to the inspector at time of inspection. Recommend repair / replacement as necessary.

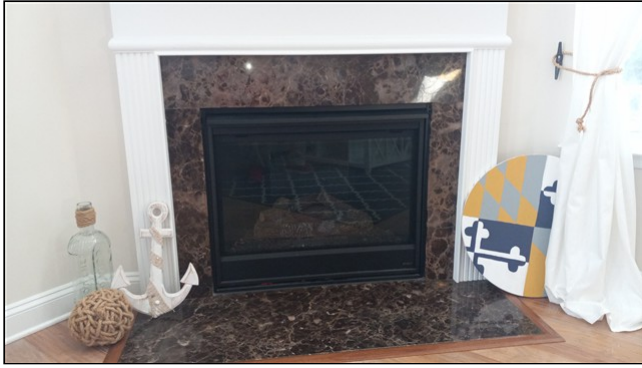
14.6 Item 1 (Picture)

The fireplace was inoperable at the time of inspection. Recommend repairs to ensure safe and proper operation.

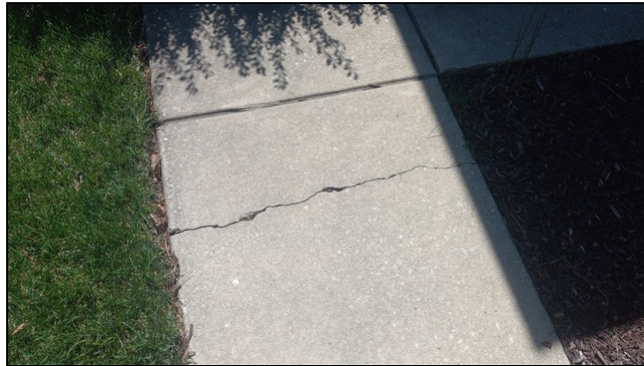
1.1 Item 1 (Picture)

Common cracks observed, primarily a cosmetic concern. We suggest sealing all cracks in surfaces to prevent water penetration as a routine maintenance effort.

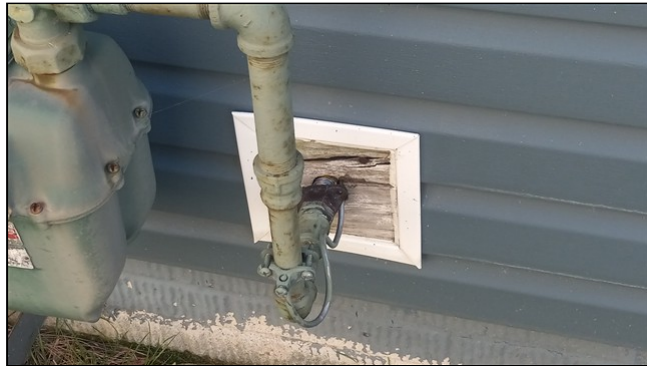
1.8 Item 1 (Picture)

Typical moisture damage observed at Trim at the gas meter . Recommend correcting to prevent further damage.

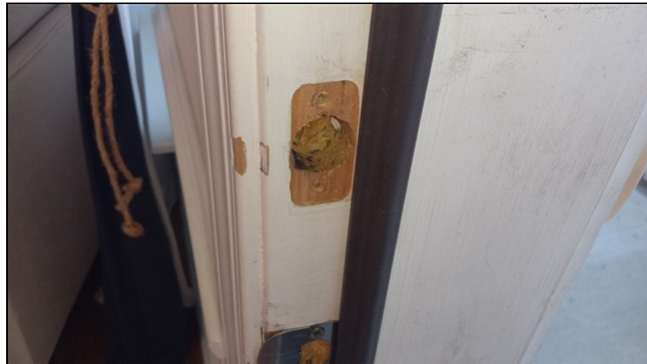
1.10 Item 1 (Picture)

The strike plate is missing on the door in the front entry. Recommend replacement for proper operation.

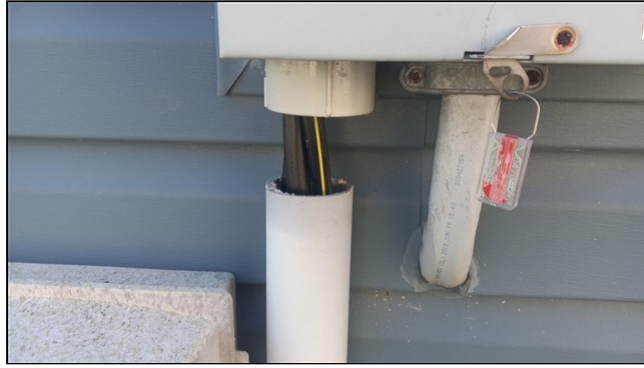
1.11 Item 1 (Picture)

Conduit is separated from the meter exposing service wires which is a possible shock hazard. Recommend contacting utility company for repair

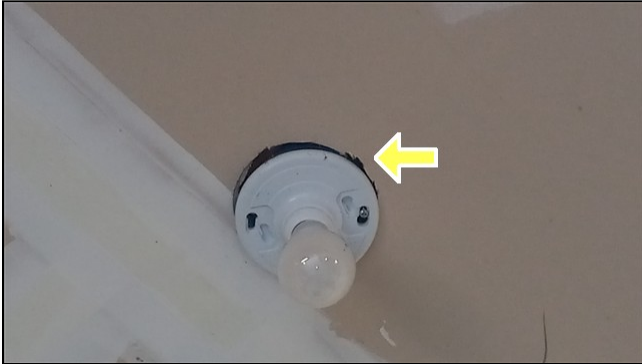
2.4 Item 1 (Picture)

Fire rating of the garage wall is compromised as a result of holes, cracking, loose drywall tape or thru wall penetrations. This is a safety concern. Recommend repairs as necessary to correct.

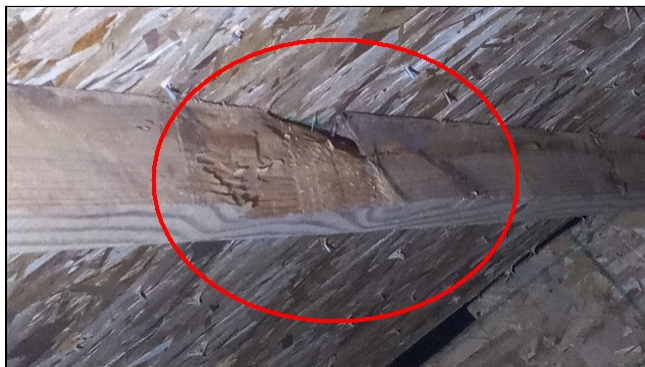
4.1 Item 1 (Picture)

Broken/damaged truss(es) observed in the main attic accessed from the 2nd floor. Trusses are engineered systems requiring each component to be intact to distribute loads as the design engineer intended. Recommend further review by manufacturers engineer and obtaining engineers written repair instructions, having a qualified contractor repair the truss according to the instructions to ensure proper structural support. Attach paperwork to repaired truss per engineers seal to have for future inspections / reference.

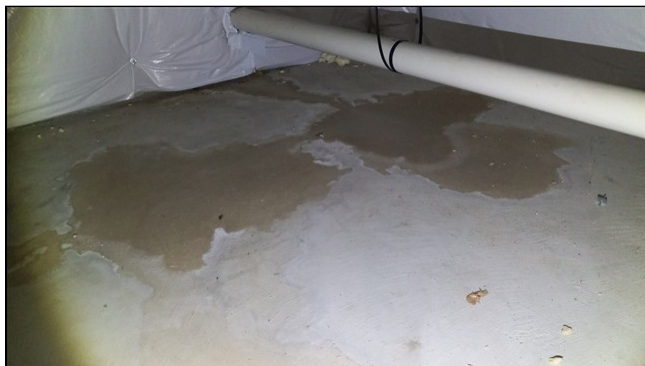
5.0 Item 1 (Picture)

Staining is present at various locations in the crawlspace which is an indication of prior moisture. Recommend further review and repair as necessary

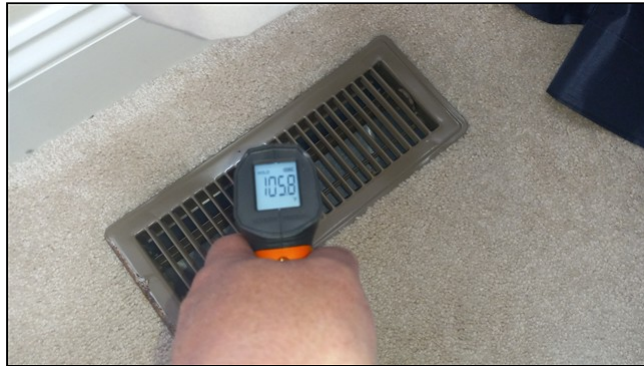
7.1 Item 1 (Picture)

The furnace was tested using normal operating controls and supplied a temperature of 105 degrees. Due to inaccessibility of many of the components of this unit, the review is limited. Holes or cracks in the heat exchanger are not within the scope of this inspection as heat exchangers are not visible or accessible to the inspector. Unit was operated by the thermostat. As with all mechanical equipment the unit can fail at anytime without warning. Inspectors cannot determine future failures.

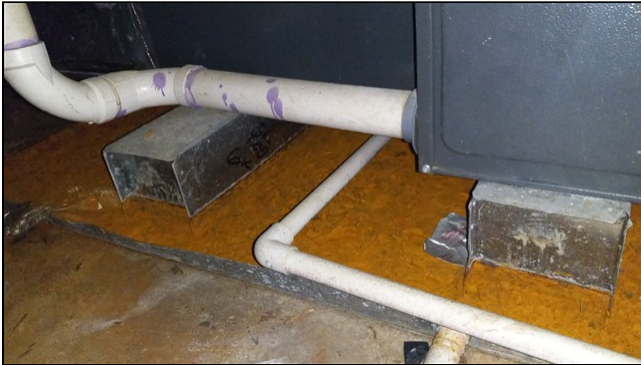
8.0 Item 1 (Picture)

Rust was noted in the emergency overflow pan of the AC unit. At some time in the past, the primary condensate drain line was not properly removing water from the inside portion of the air conditioning system. We are unable to determine if the problem will recur. Recommend consulting sellers for additional information or a licensed HVAC contractor to make any repairs necessary to assure serviceability of the condensate removal system.

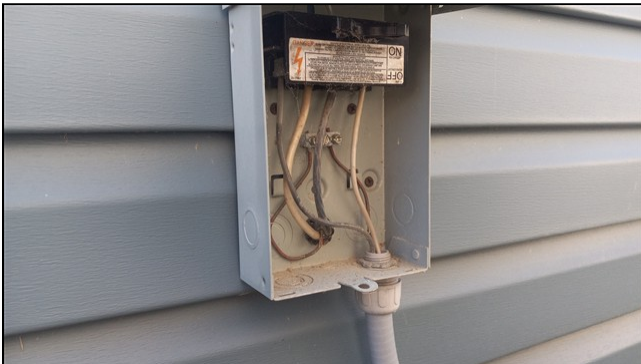
8.3 Item 1 (Picture)

The wiring is exposed. Recommend repair as necessary.

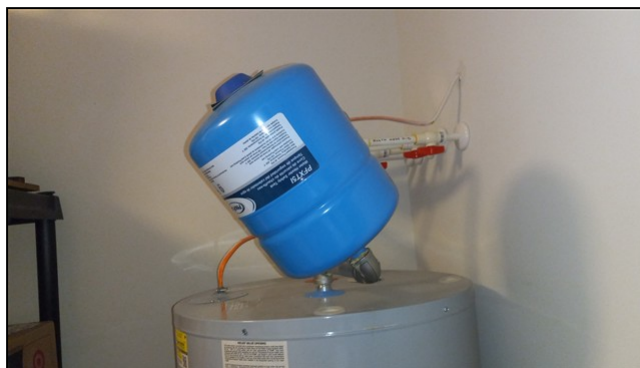
10.0 Item 1 (Picture)

A support strap has not been installed to support the expansion tank.  
Recommend installing to prevent stress/strain and future leakage.

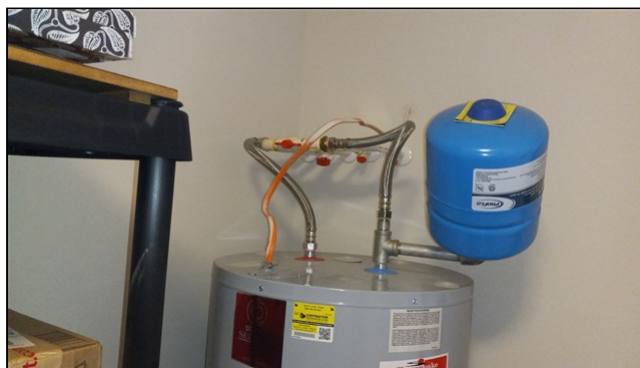
10.2 Item 1 (Picture)

No electric disconnect observed at water heater. Suggest installation of an electric disconnect to enhance safety.

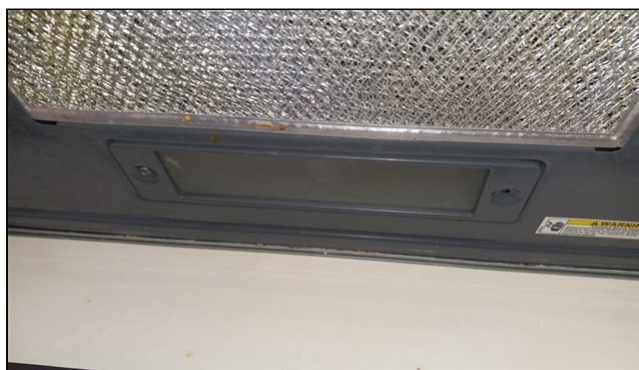
11.5 Item 1 (Picture)

The light bulb did not operate. This may be a spent bulb or some other issue. Recommend having seller demonstrate that it works prior to settlement.

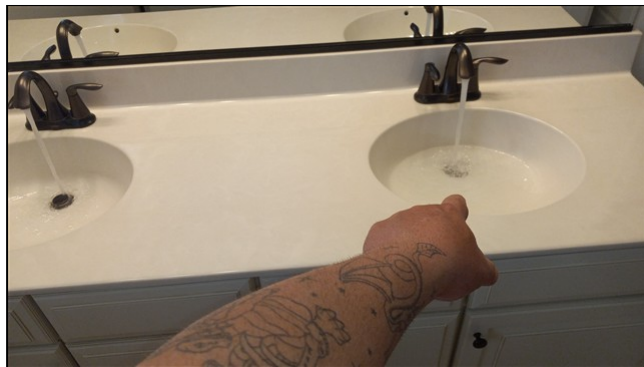
12.1 Item 1 (Picture)

The sink does not drain properly (clogged / slow draining) at the master bathroom. Recommend repairs as needed.

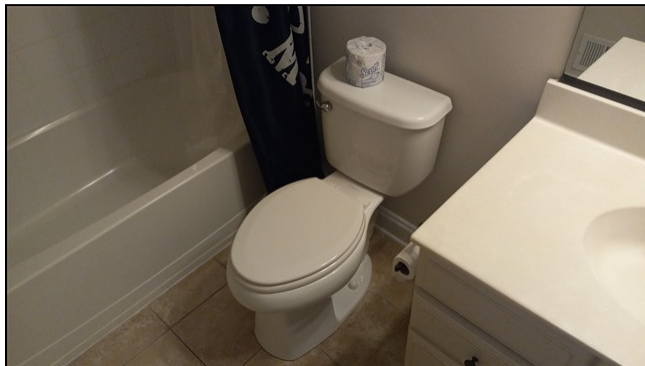
12.2 Item 1 (Picture)

prevent water leakage and damage to the sub-floor area. This type of damage is not always visible or accessible to the inspector at time of inspection. Recommend repair / replacement as necessary.

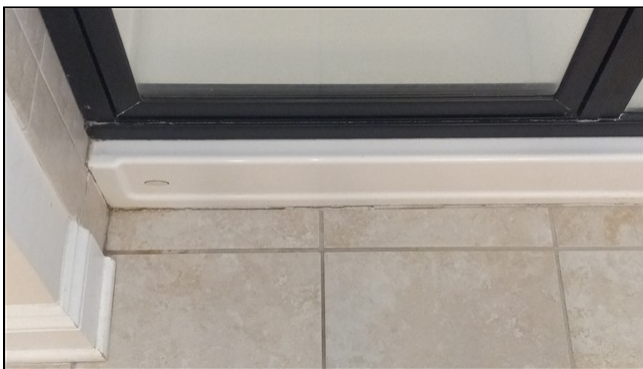
12.3 Item 7 (Picture)

Openings in grout/caulk observed in the master bathroom. Any openings to include edges of the tub/shower surrounds and spouts should be caulked to prevent moisture penetration. Failure to keep these areas sealed can cause deterioration and moisture damage to the interior walls, which is not always visible to the inspector at the time of inspection.

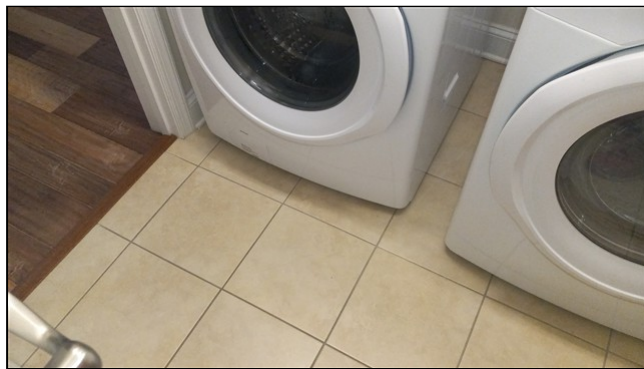
13.0 Item 1 (Picture)

The overflow pan is missing.  
Recommend installing as the unit is  
located above or within living space

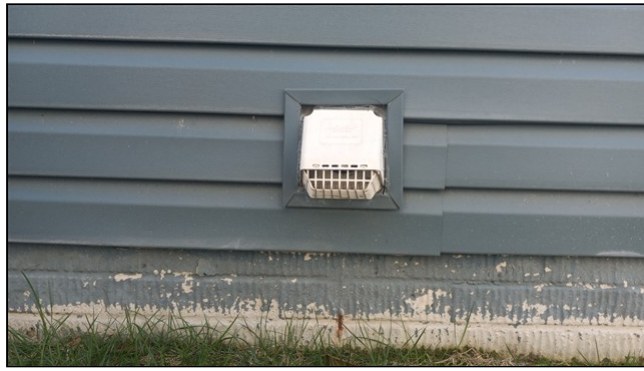
13.2 Item 1 (Picture)

Screen installed on exterior vent cover is considered improper and a potential fire hazard, recommend removing.
