Wood Destroying Insect Inspection Report

Inspection Company, Address & Phone
Home Solutions Property Services
108 Isaacs Shore Drive
Milford, DE 19963
302-722-6440

Company's Pest Control Business Lic. No.
DE 1840
Address of Property Inspected
514 North Willey Street, Seaford, DE 19973

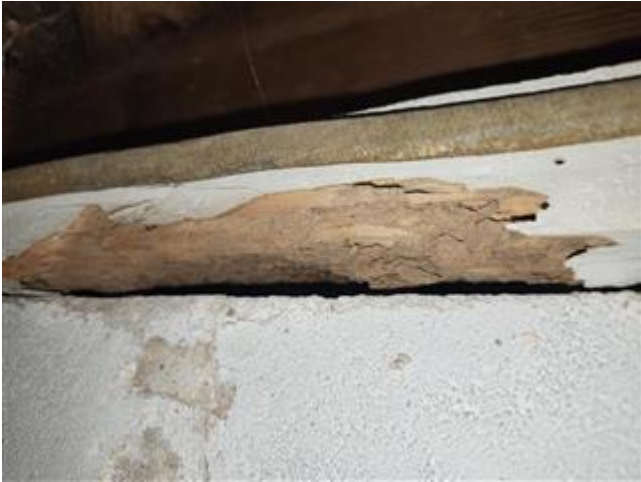
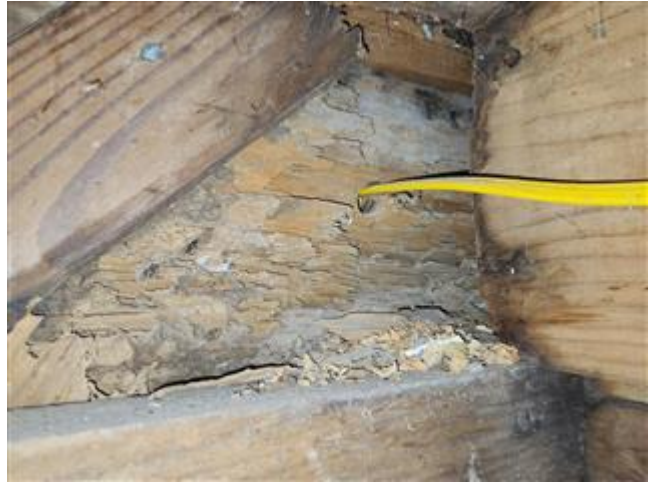
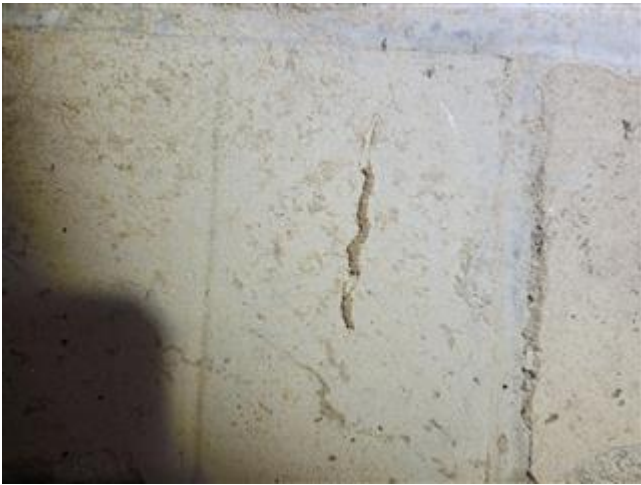
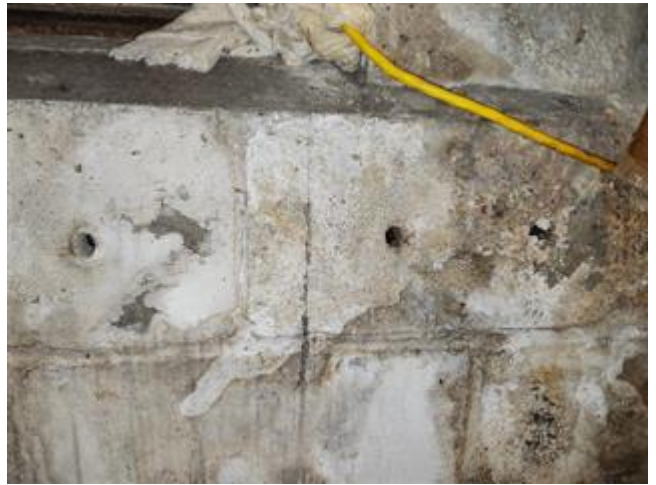
Additional Pictures

- ☐ 1. Live insects (description and location): _____
- ☒ 2. Dead insects, insect parts, frass, shelter tubes, exit holes, or staining (description and location): _____
Tubes in the basement and attic.
- ☒ 3. **Visible** damage from wood destroying insects was noted as follows (description and location): _____
Termite damage on framing in basement.

- ☒ No action and/or treatment recommended: (Explain if Box B in Section II is checked) _____
Treatment present at the time of inspection.
- ☐ Recommend action(s) and/or treatment(s) for the control of: _____
